# Manhole Inspection Summary

Manhole # S27U\_\_002MH

Insp Date: **4/23/08 10:53 AM**

**Location** Address: **1645 Bush st**

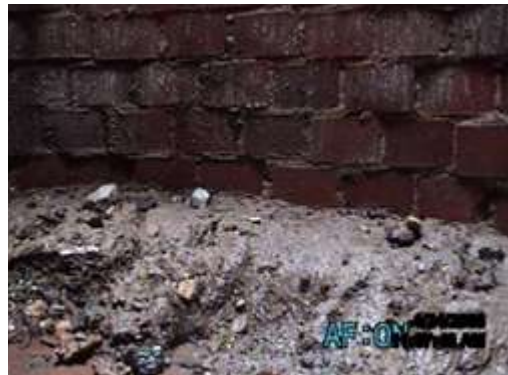
Defect 3

Condition: ☐ Sound ☐ Cracked ☐ Root Intrusion ☐ Deteriorated ☐ Leaks ☒ **Debris**

debris on bench

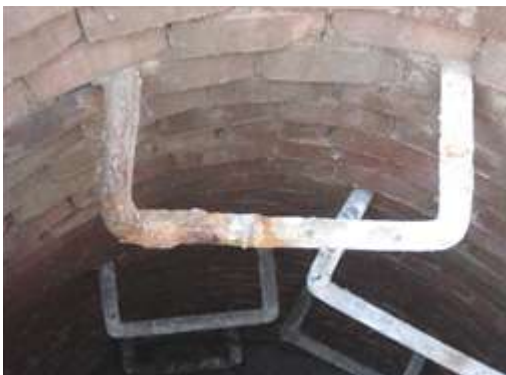
Defect 1

☒ **Corroded**

rusted rungs

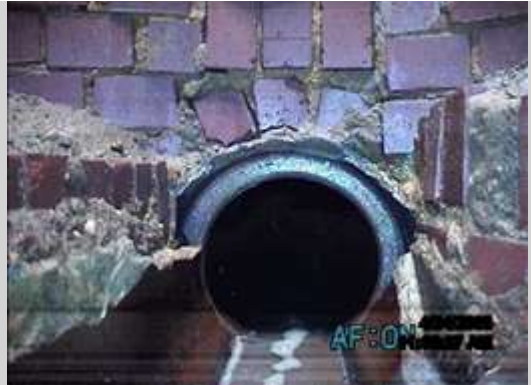
12 O'Clock Outflow

8 in. Circular Gravity Sewer  
Pipe Out @ 12 O'Clock

Pipe Height: **8.4** (in.) Rod and Bar (Angled)  
Pipe Material: **Clay** ☐ Pipe Lined  
Invert Depth: **10.46** (ft.) Flow Characteristics: **Slow**  
Deposits: ☒ None ☐ Mud ☐ Sludge ☐ Debris ☐ Grease  
Silt Depth: **0** (in.) Deposits Extent:  
Infiltration: **None** Pipe Seal Cond: **Sound**

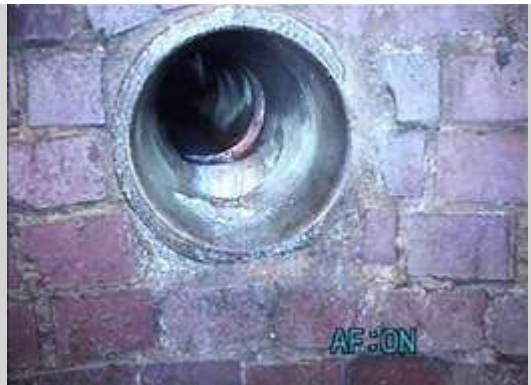
3 O'Clock Inflow

8 in. Circular Gravity Sewer  
Pipe In @ 3 O'Clock

Pipe Height: **8.4** (in.) Rod and Bar (Angled)  
Pipe Material: **Clay** ☐ Pipe Lined  
Invert Depth: **7.80** (ft.) Flow Characteristics: **Slow**  
Deposits: ☒ None ☐ Mud ☐ Sludge ☐ Debris ☐ Grease  
Silt Depth: **0** (in.) Deposits Extent:  
Infiltration: **None** Pipe Seal Cond: **Sound**

Drop: **Outside** Rod and Bar  
Angled: **Yes** Reading: **8.98** (ft.)  
Inv Depth: **9.98** (ft.)

Drop Condition: **Open**

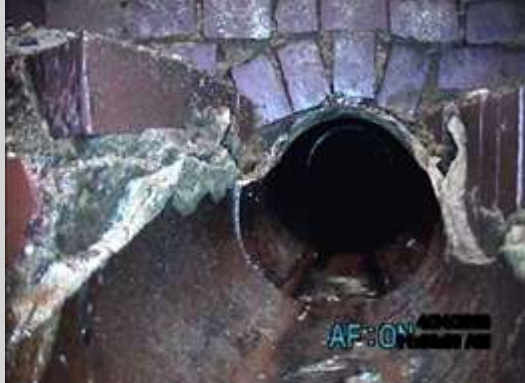
6 O'Clock Inflow

Pipe In @ 6 O'Clock

Pipe Height: **8.4** (in.) Rod and Bar (Angled)

Infiltration: **None** Pipe Seal Cond: **Sound**
